Chapter 12: Management and Restoration of Coastal Ecosystems

This chapter provides an overview of the management and restoration activities associated with coastal ecosystems within the South Florida Water Management District (SFWMD or District). In addition to this year's consolidated reporting efforts, this chapter's coverage of coastal ecosystems supports the overall objective of the *2007 South Florida Environmental Report – Volume I* (SFER) to provide a comprehensive view of the South Florida environment within the District's boundaries. As an update to previous editions of Chapter 12 of the SFER – Volume I, the information covered in this chapter focuses on products, events, and scientific insights gained for Water Year 2006 (WY2006) (May 1, 2005 through April 30, 2006). The reader is encouraged to review previous editions of SFER for background information not provided in this year's document.

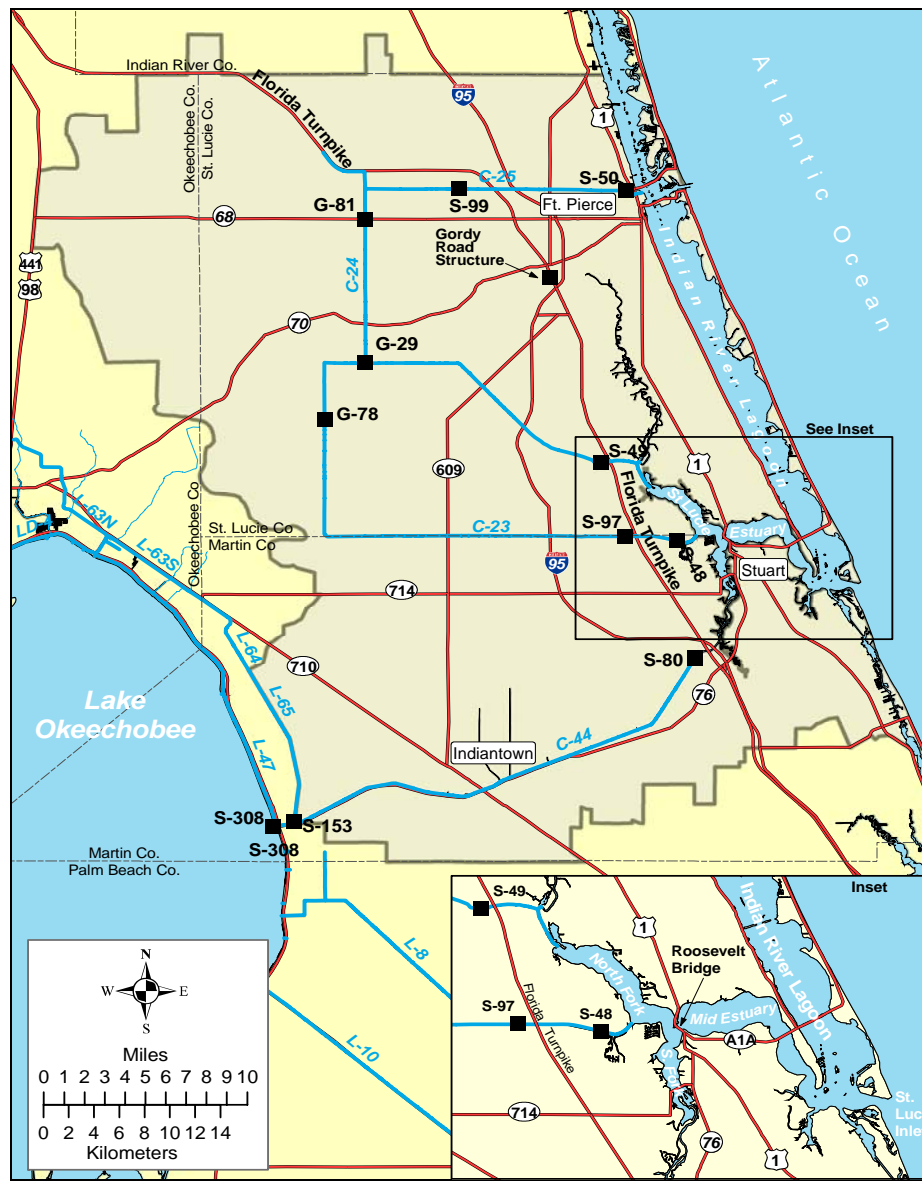
Figure 12-2. Map showing the locations of the Southern Indian River Lagoon (SIRL), St. Lucie Estuary (SLE), and major water management canals that discharge into these estuaries.

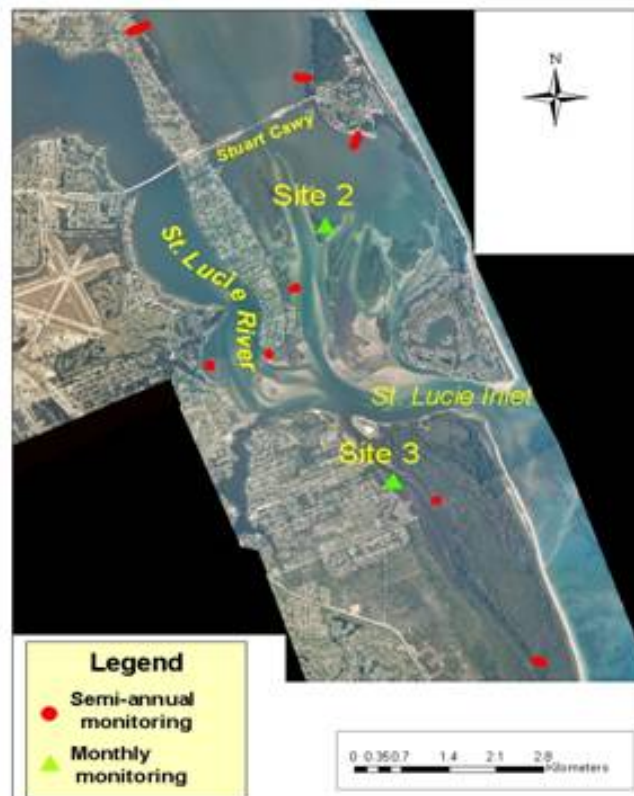
Figure 12-7. Location of monthly and semi-annual seagrass monitoring stations influenced by St. Lucie River discharges during WY2006.

Monthly data collected at two sites (Sites 2 and 3 in **Figure 12-7**) that were influenced by St. Lucie Estuary discharges illustrates the degree of impact to seagrass resources near the mouth of the St. Lucie River (**Figures 12-8 and 12-9**). Manatee grass (*Syringodium filiforme*) shoot counts and canopy heights continually declined throughout WY2006, with slight recovery apparent during spring 2006.

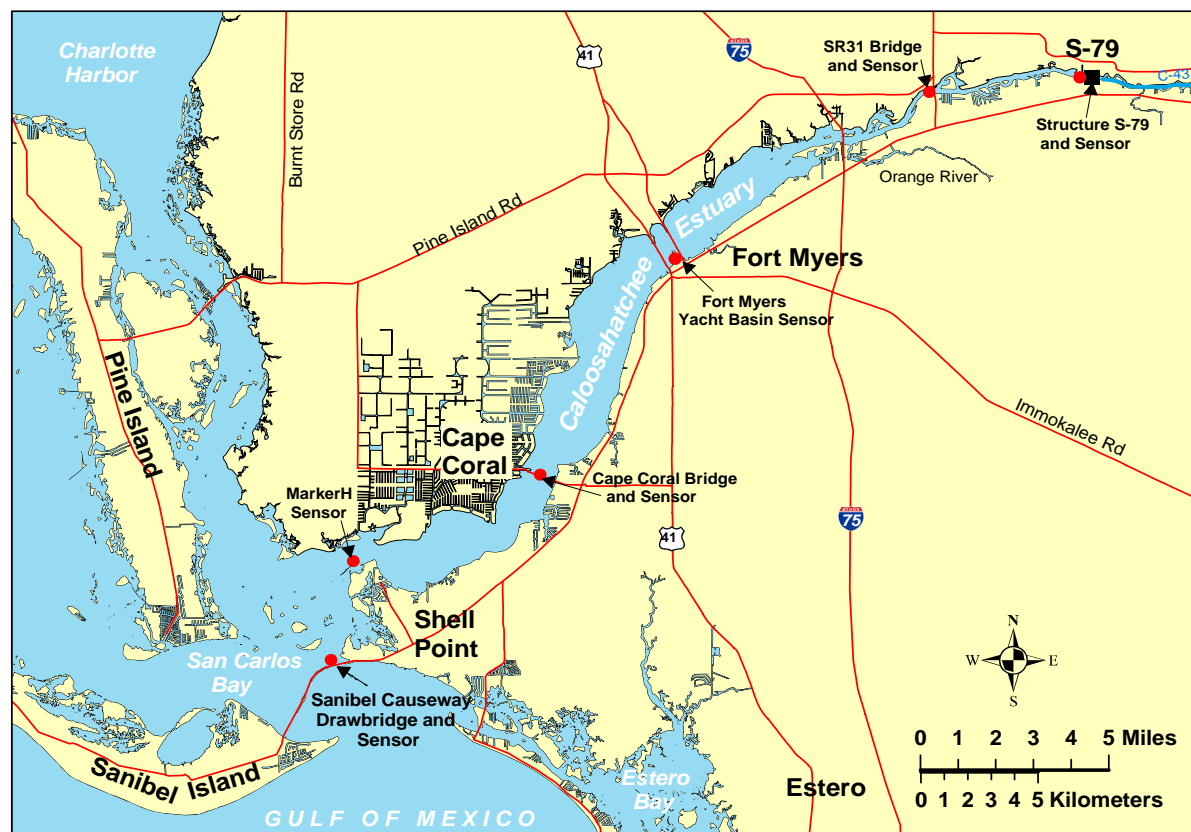
Figure 12-24. Caloosahatchee Estuary salinity sensors and landmarks.

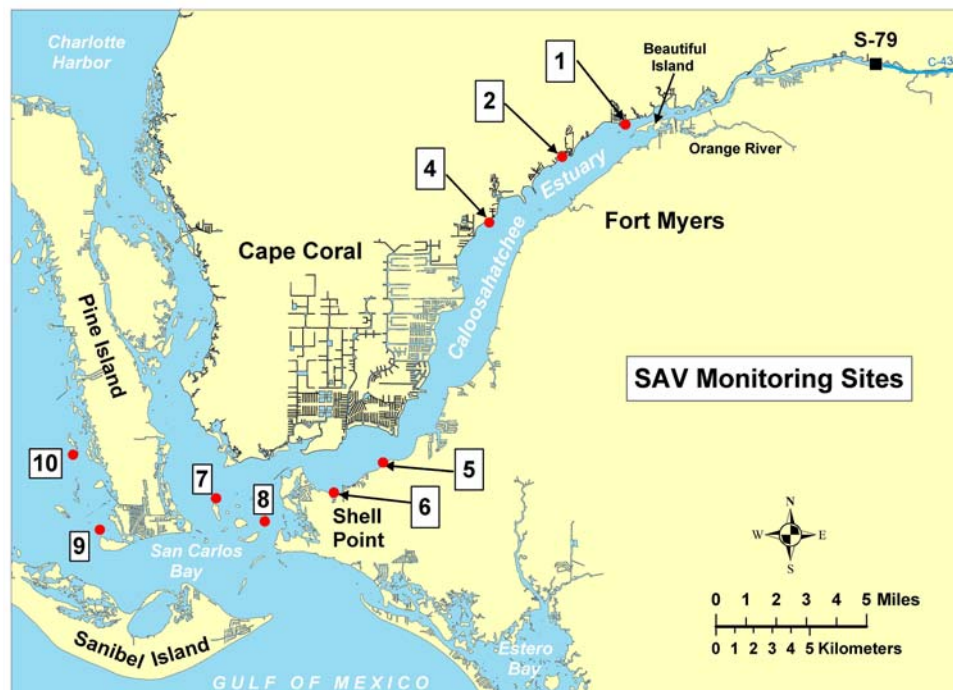
Figure 12-27. Caloosahatchee Estuary SAV monitoring stations and oyster locations. *Vallisneria americana* is found at stations 1–4, *Halodule wrightii* at stations 5–10, and *Thalassia testudinum* at stations 8–10. The area between stations 6 and 7 has the core oyster population, though oysters are located throughout the region downstream of Station 5.

Hydroacoustic sampling of SAV during the growing season was conducted for the tenth year. Except for Site 4, sampling locations include all sites depicted in **Figure 12-27**.
